QUALITY CONTROL OF XLPE CABLES BY MEANS OF IMPULSE VOLTAGE TEST

Rudolf WOSCHITZ, Walter PANOSCH*), Gerald KNOLLSEISEN, Christof SUMEREDER
TU Graz, Institute of High Voltage Engineering and System Management, Austria
*) EVN AG, Austria

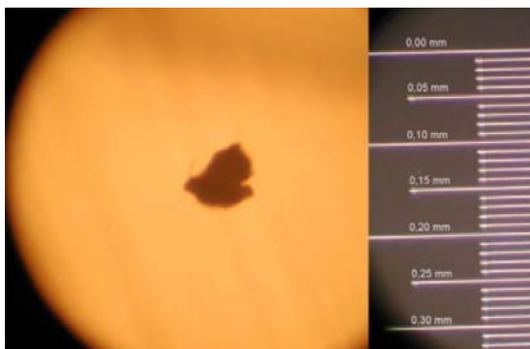
The following figures show microscope takings of thin films of the defective areas of two samples with low voltage levels. The electrical trees on the rim of the breakdown channel are showing, that the breakdown is directed inwards for both defective areas. Because of field geometry breakdowns in homogenously isolated cables are always directed outwards. Breakdowns with an inwards direction can only occur with abnormal local field distortion in caused by inhomogeneities in the insulation respectively in the interface between insulation and semi conductive layers. The latter inhomogeneities didn't show any particularities during the optic examination. The interfaces were smooth and no irregularities occurred. Figs.2 and 3 show shots of sample 1. In Fig. 2 one can recognize an impurity of about 55 µm.

Fig. 2: Impurity of 55 µm in sample 1, impulse test level 480 kV
